City of Miami Cemetery  
Marker and Monument Condition Survey Report  
Conducted Winter/Spring 2020

*Prepared for*  
**Dade Heritage Trust, Inc.**  
**Florida Department of State**  
Division of Historical Resources

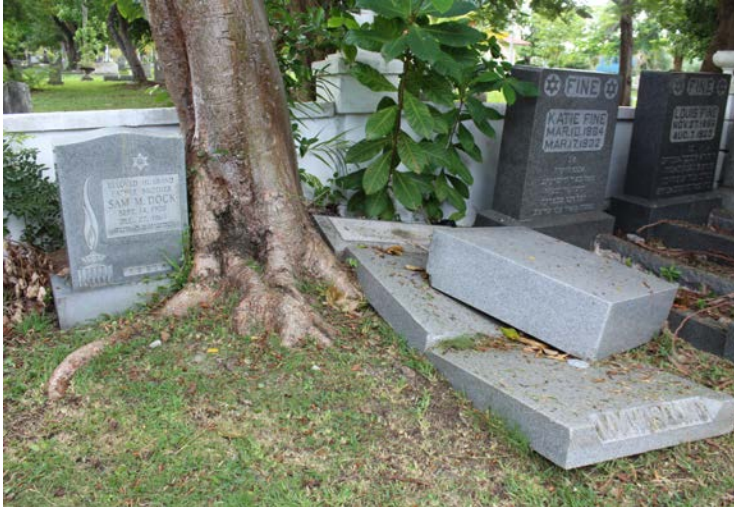
*Although vegetation generally does not have a negative impact in the cemetery, there are certain location such as Jewish section where the roots of large trees have caused the collapse of markers or threaten their stability.*

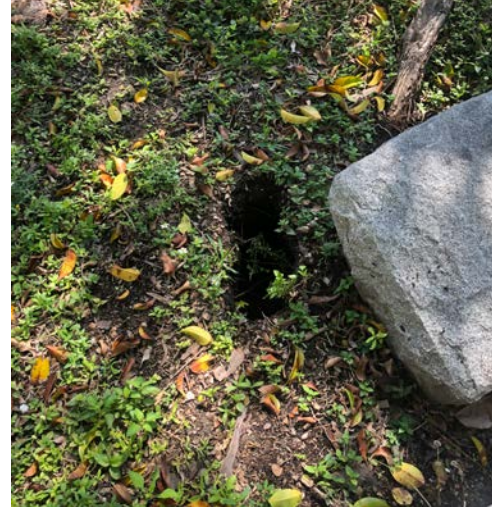
The ground in the southeastern portion of the cemetery was found to be soft and unstable. A surveyor's foot punched into the ground near a marker.
