City of Miami Cemetery
Marker and Monument Condition Survey Report
Conducted Winter/Spring 2020

Prepared for
Dade Heritage Trust
190 Southeast 12 Terrace
Miami, FL 33131

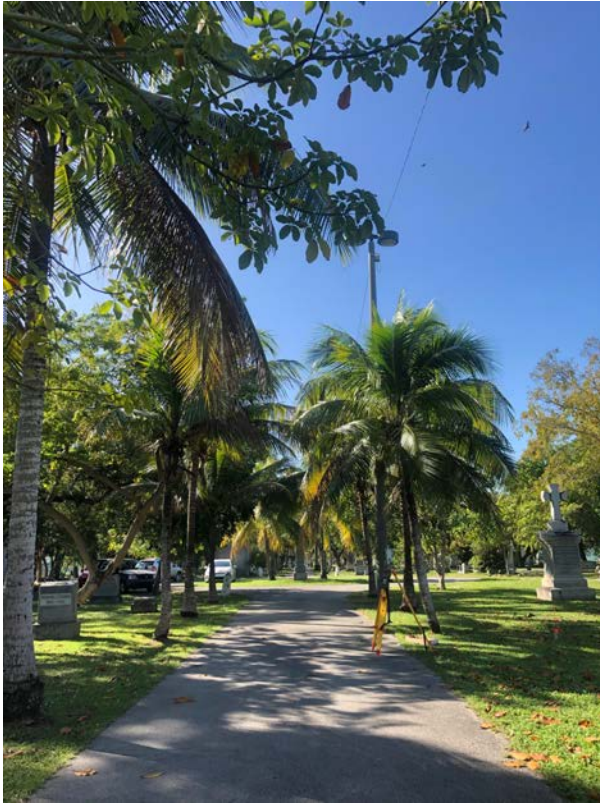
There is one public two-way road that bisects the City of Miami Cemetery. There are two traffic circles that include grave markers and monuments.

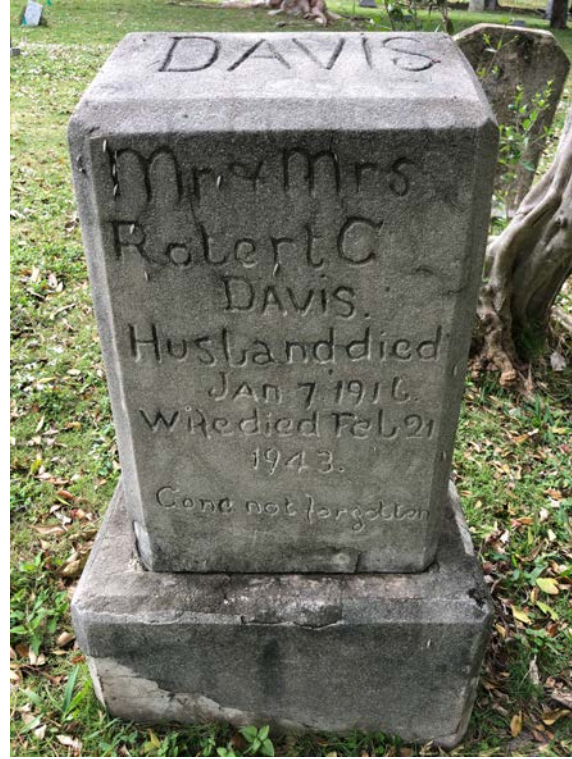
A hand carved marker found in the African American section of the cemetery. There are less than 20 of these hand carved markers.

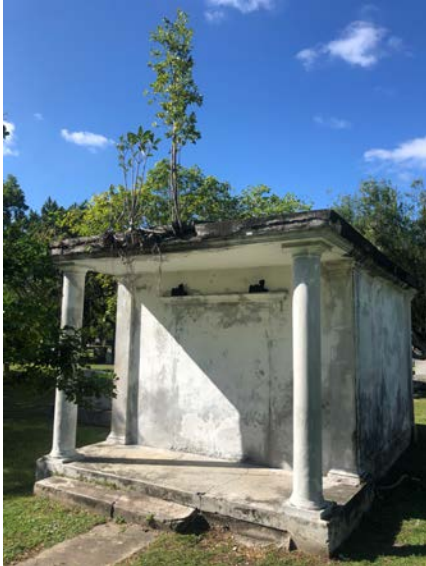
Overall image of the only mausoleum to score a "poor" condition rating. Structural cracks and vegetation put this structure at high risk of continued deterioration and intervention should be prioritized.

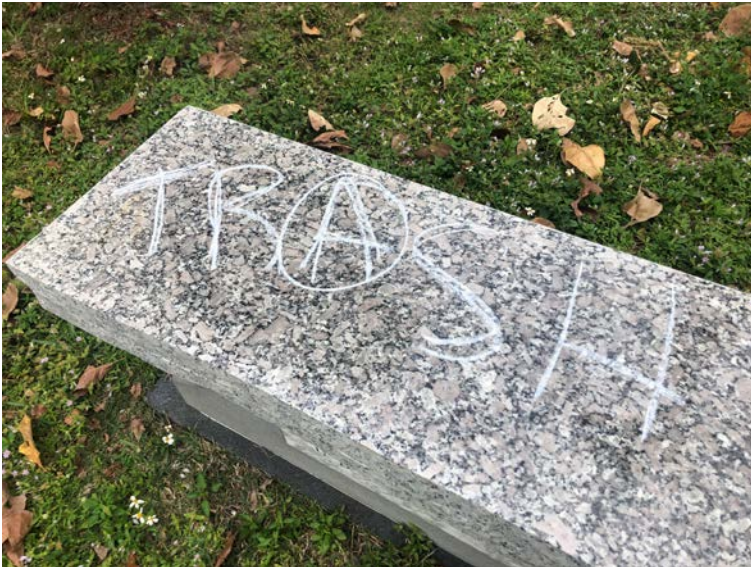
Examples of vandalism on one of the monuments in the Confederate Circle. The cemetery grounds crew promptly acted in removing this graffiti. It is recommended that photographs be taken of such instances prior to treatment and after for documentation purposes.

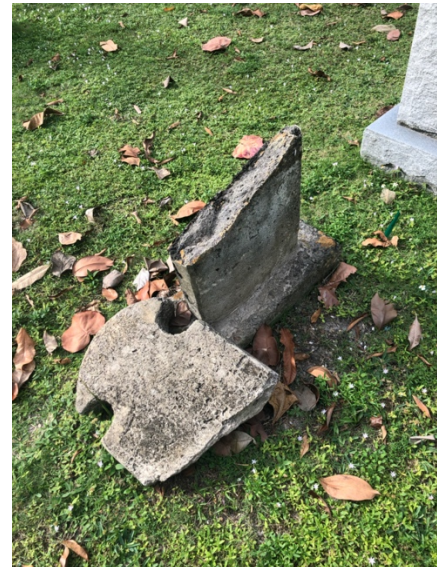
Example of a marker in poor condition but high integrity that should be prioritized when determining an overall treatment approach at the cemetery.

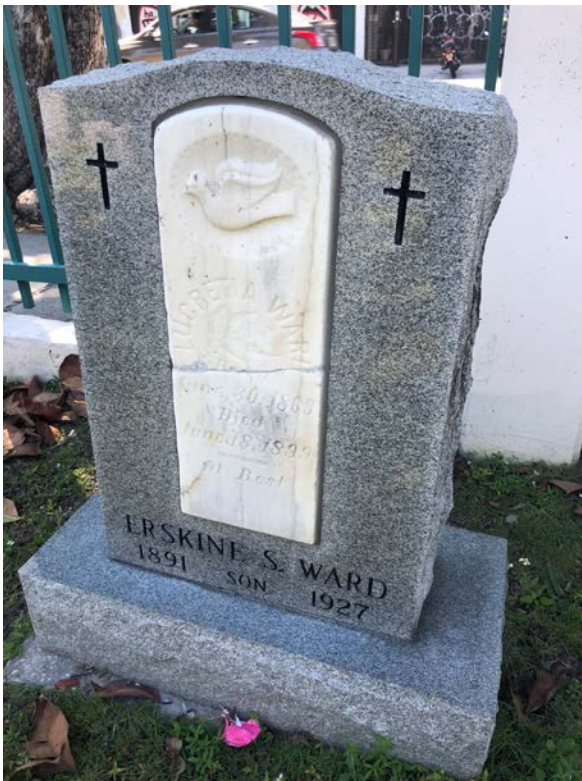
19th century marble grave marker that was conserved by inserted into a modern granite marker. Found on the western boundary of the cemetery.

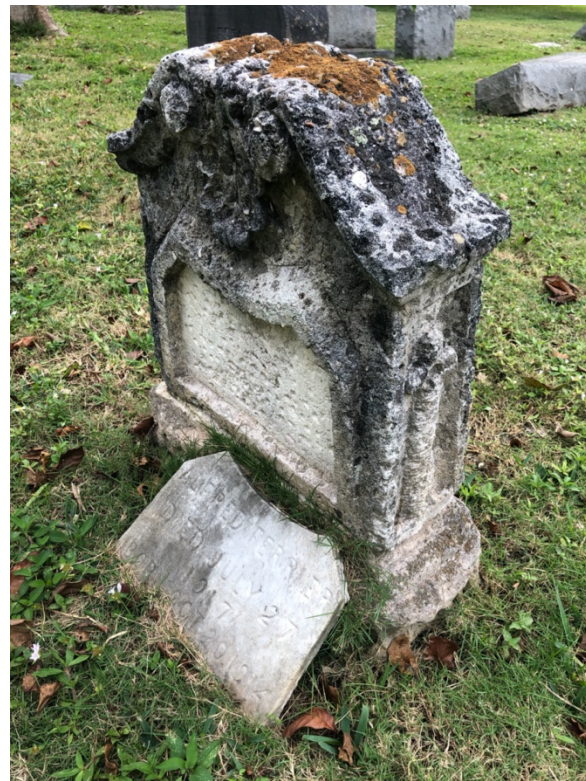
One of the five (5) coral stone (oolitic limestone) markers with its detached marble plaque. This marker should be prioritized when determining overall cemetery treatment priorities due to the uniqueness of the material.
